## ENVIRONMENTAL MANAGEMENT AND PERFORMANCE

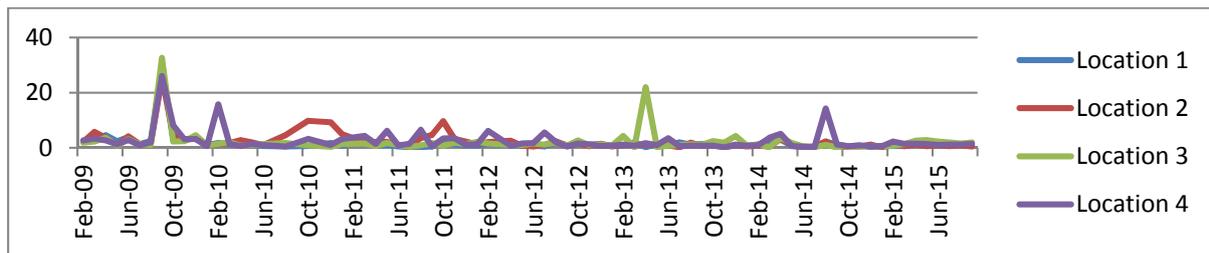
**Figure 1: Dust levels (5yrs)**

The graphical representation depicted below indicates measured dust levels over the period of collection of data for the 12 month period.

- Location 1** Herb cottage/Costell’s Vineyard as identified on dust monitoring location map dated 22/2/08
- Location 2** Property labelled as “Old Post Office” on figure 2.1 Generalised project site layout pg 21 of Broula King Gold Mine EIS 2005
- Location 3** Property labelled as “Shadelands” on figure 2.1 Generalised project site layout pg 21 of Broula King Gold Mine EIS 2005
- Location 4** Southern boundary of “Shadelands” property as identified on map dated 22/2/08

The elevated results in June/September coincide with increased annual agricultural activity (soil cultivation).
